(Volume 7, Issue 2 - V7I2-1367)

Assessment of deterioration in RCC building

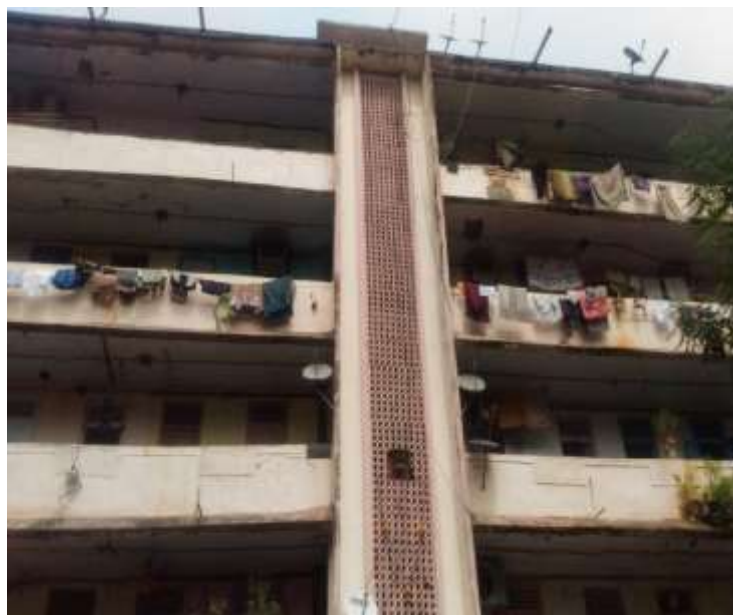
Distressed RCC Findings.

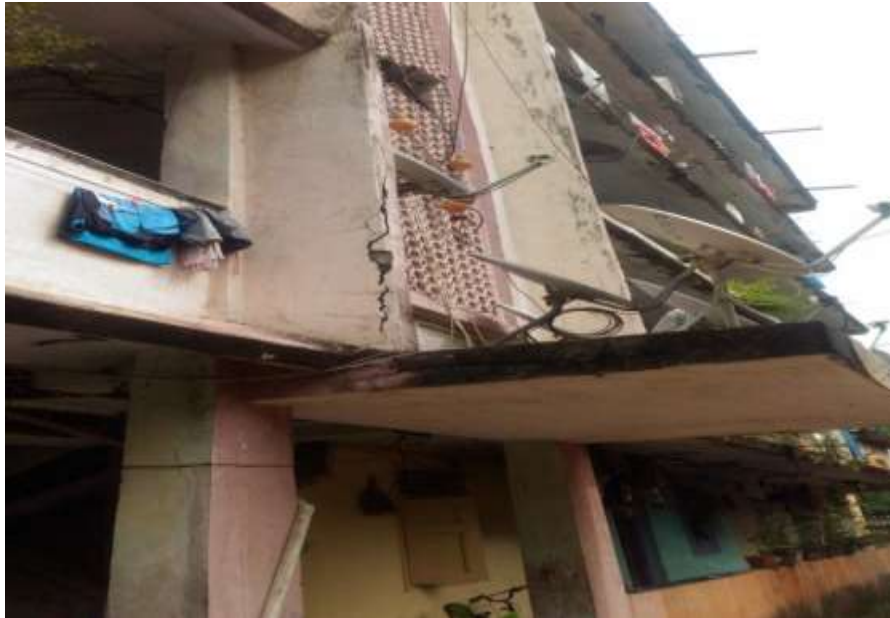
Structural Cracks on the Staircase Passage.

Peelings of paints observed at staircase area.
 Black molds are observed at some points.
 Structural cracks at staircase columns& beams are observed.

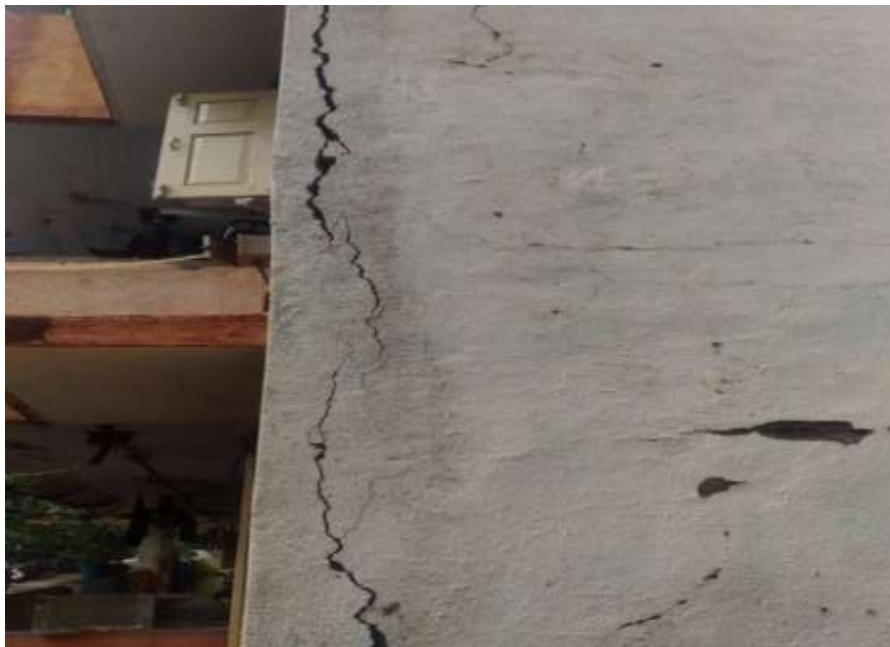
Structural Cracks on the Dead wall.

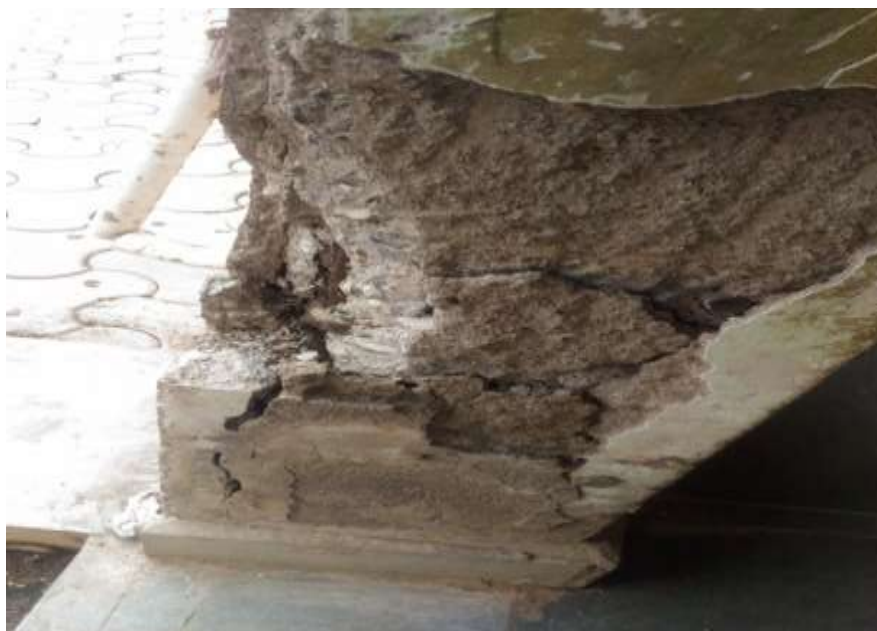
RCC column failure.

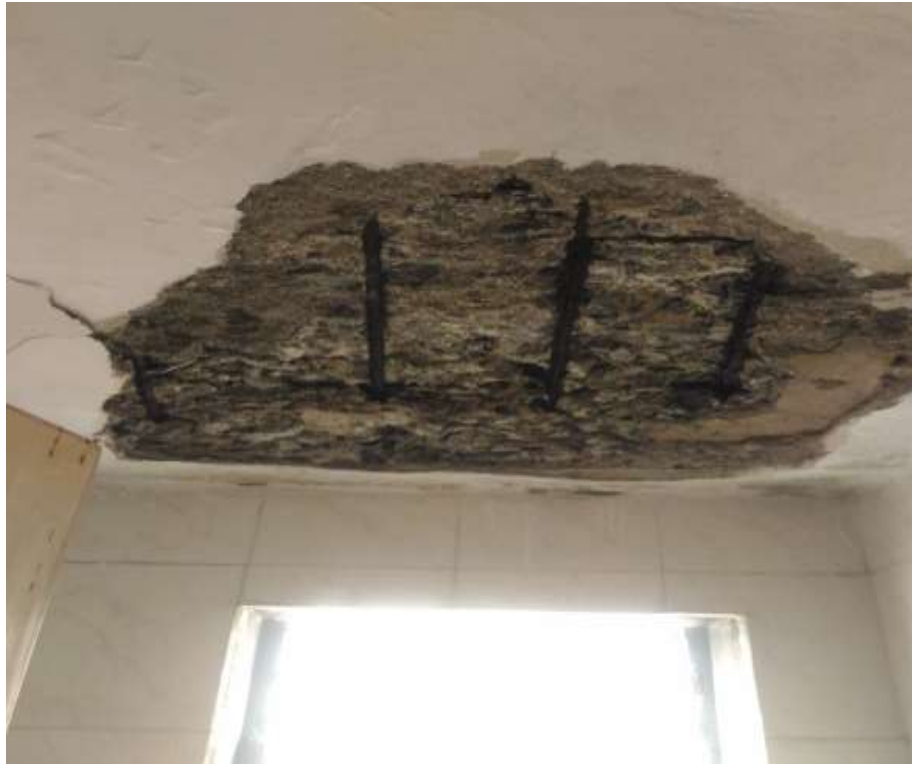
Concrete chipping off from slab exposing reinforcement.

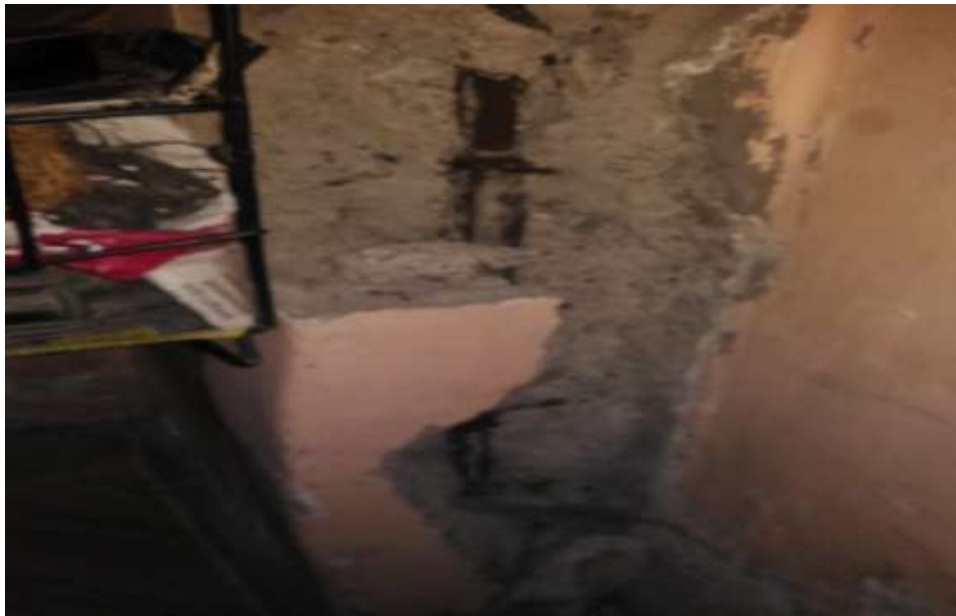
Exposed reinforcement.
