INTERNATIONAL JOURNAL OF ADVANCE RESEARCH, IDEAS AND INNOVATIONS IN TECHNOLOGY

Assessment of the seismic vulnerability of San Guillermo parish church and San Agustin parish church in Pampanga

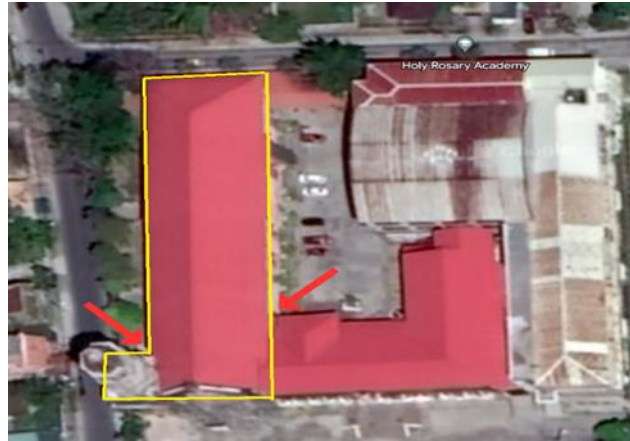
Figure 16. Aerial View of San Agustin Parish Church, Note. Retrieved from Google Maps, April 10, 2023

Figure 16 shows the aerial view of San Agustin Parish Church through the use of a mapping and navigation application. The church has a plan irregularity having an L shape pattern and is considered to have reentrant corners where damage is more prone and visible to the corners. Arrows indicate possible areas of damage.
