INTERNATIONAL JOURNAL OF ADVANCE RESEARCH, IDEAS AND INNOVATIONS IN TECHNOLOGY

(Volume 9, Issue 2 - V9I2-1366)

Proposed design of The Existing Dike Along Sitio Delta, Consuelo, Macabebe, Pampanga

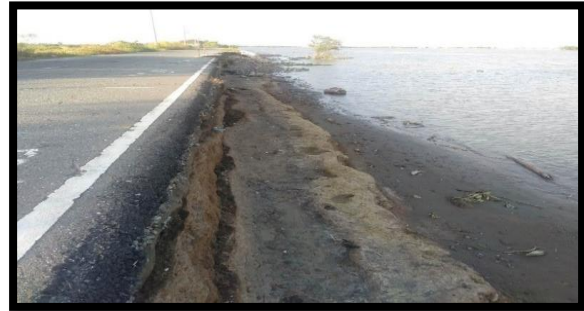
Figure-1: Actual Condition of the Sitio Delta, Consuelo Dike

Five puroks made up Barangay Consuelo, including Sitio Delta, which serves as the barangay's extension. This Sitio is divided into Tora-Tora and Delta, which are both located next to the Pampanga River. The Consuelo Dike at Sitio Delta, which protects the residents of Barangay Consuelo from floods, strong waves, and potential high floods, is progressively deteriorating over time. Because the aforementioned dike is an earth-fill dike and is surrounded by water, erosion occurs frequently and causes damage, particularly on its side. If the erosion persists and is not stopped right away, a serious issue could result, such as the dike breaking entirely.
