## Seismic retrofitting of existing reinforced concrete building

*It is commonly observed that many RC Building collapses during an earthquake are those building which is non-engineered or those RC Buildings which are not constructed as per codal provisions. Some of such buildings have deficiencies in whole structure or individual structural members which don't have the adequate lateral capacity to counter the seismic demand. Before retrofitting of structure it is required to perform necessary assessments and evaluations of structural member or location deficiencies are found. In this case study, a G+3 storey RC Building is considered for seismic analysis which is located in the zone -IV to calculate the additional seismic strength of structural members like beams and columns. Based on this analysis retrofitting measures are suggested. This analysis is performed by using Stad pro-V8i software. The recommendations are based on IS - 15988, IS - 1893, IS - 13920 and FEMA codes provisions. The method adopted for seismic retrofitting of structures is RC Jacketing.*

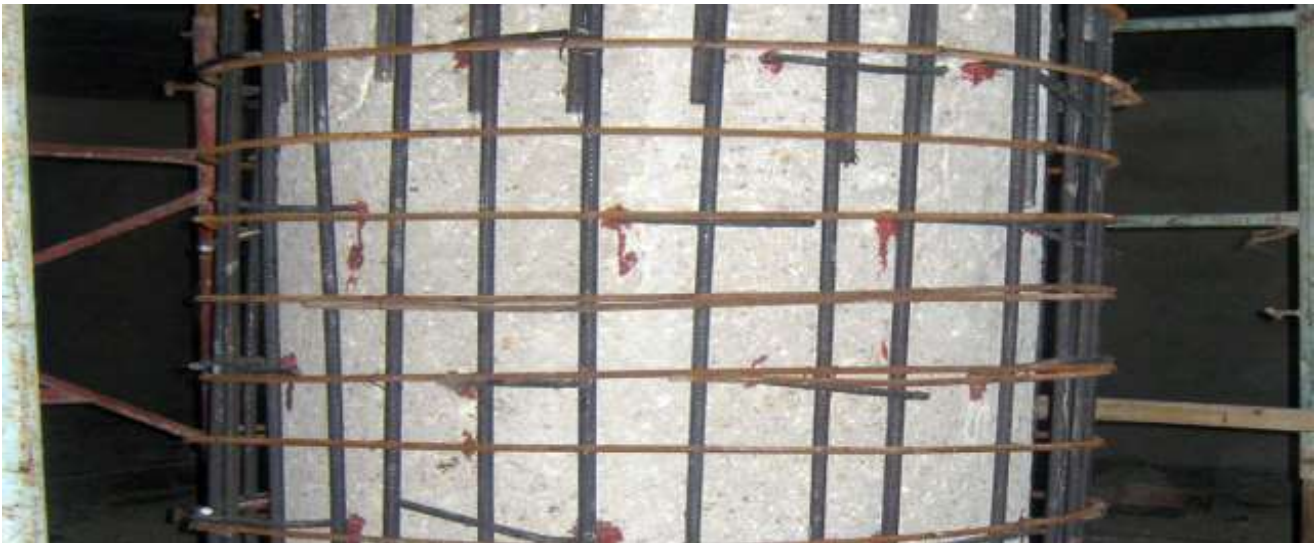
Fig. 3: RC Jacketing of Column

The retrofitting technique used in this analysis is RC Jacketing. RC Jacketing is popularly used retrofitting technique to strengthen the columns and beams. The main objective of Jacketing is to increase to increase the size of columns and beams. Increasing size of columns and beams increases the stiffness of the members. RC Jacketing improves the buckling capacity of the members.

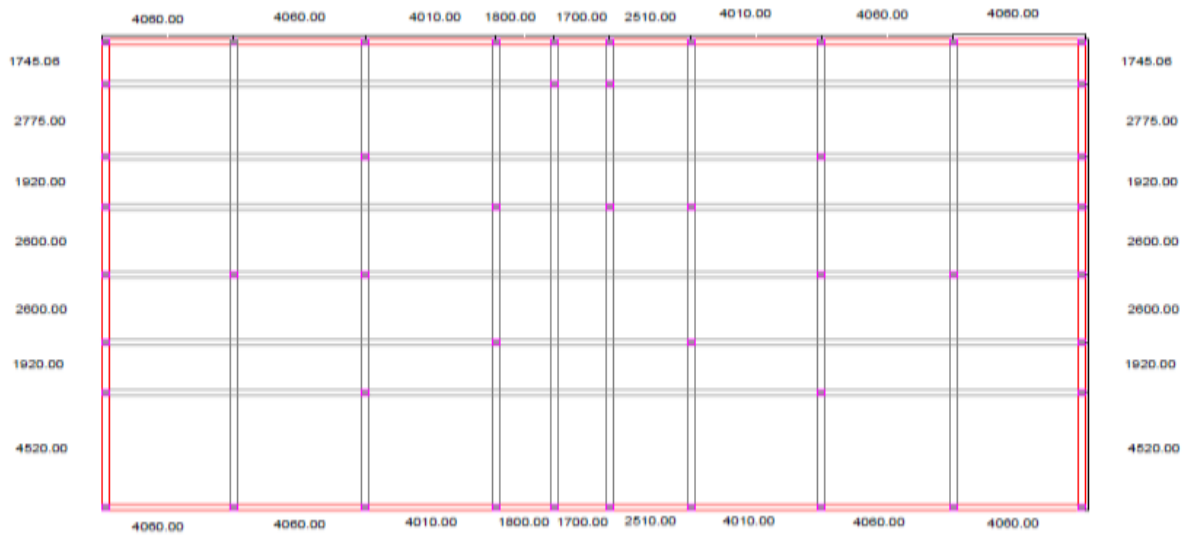
Fig. 5: Plan of Existing Building

In this analysis the detailed design of existing G+3 RC Building is being collected which is analyzed by using Stadi pro V8i software the structure was safe but when the same structure is analyzed for G+5 storey building few of the columns fail. After retrofitting columns which were failed by increasing its size and area steel required by using Stadi pro-V8i software. After retrofitting of G+5 storey building it was further checked for its safety the structure was found safe. The plan and elevation of G+3 and G+5 storey building are given in figure 5, 6 and 7 below.
