INTERNATIONAL JOURNAL OF ADVANCE RESEARCH, IDEAS AND INNOVATIONS IN TECHNOLOGY

Development of Al-Alloy piston coating material for high specific power engine application

Vikrant Kate

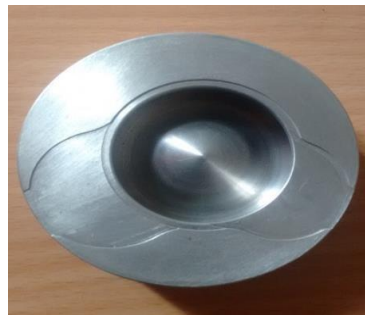
Fig. 2: Research Piston

Thermal barrier coating is mainly done on combustion chamber component like piston, cylinder head, linear, valves, combustion chamber etc. The piston is one of the most critical component of the engine therefore it must be designed to withstand from damage that is caused due to extreme heat and pressure of combustion process. Hence, in present study, it was decided to coat TBC on the piston crown and study the efficiency of LHR engine. However, due to unavailability of LHR engine, research piston which is replicating LHR piston crown of same material were used in this present study [5].

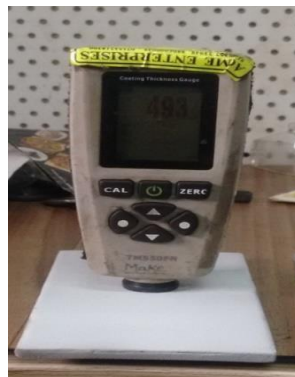
The coating thickness on substrate is measured by Digital Film Thickness machine (DFT) as shown in. Dry Film Thickness was measured on either magnetic steel surfaces or non-magnetic metal surfaces. Firstly, the machine is set on zero at substrate surface. Check the thickness of bound coat after application of bound coat material. Further, coat the bond coat layer by top coat layer and check the total thickness.

Fig. 5: Digital Film Thickness machine (DFT)

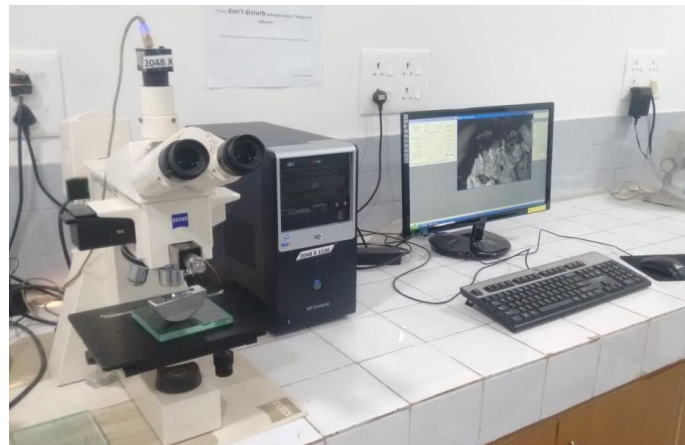
Initially, visual inspection was carried out on the coating surface to check the uniformity of coating and also macro level defects such as cracks, porosity, etc. Along with research piston, a test coupon was also coated to examine the coating uniformity, thickness and bonding between substrate and coating layers. The cross section of the research piston was analyzed after thermal shock and thermal barrier tests to check whether coating is intact with substrate or any delamination. Microstructural examination of metallographic samples was carried out using optical microscope (Carl Zeiss AXIOTECH100).

Fig. 6: Optical Microscope

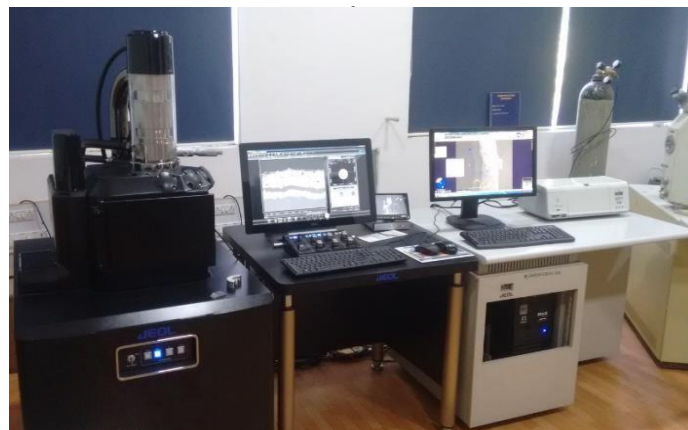
Coating uniformity, bonding between substrate and coating layers, thickness and chemical composition of coating were analyzed using Scanning Electron Microscope (JSM-IT300) equipped with Energy Dispersive Spectrometer (EDAX - Octane plus).

Fig. 7: Scanning Electron Microscope with EDS Attachment

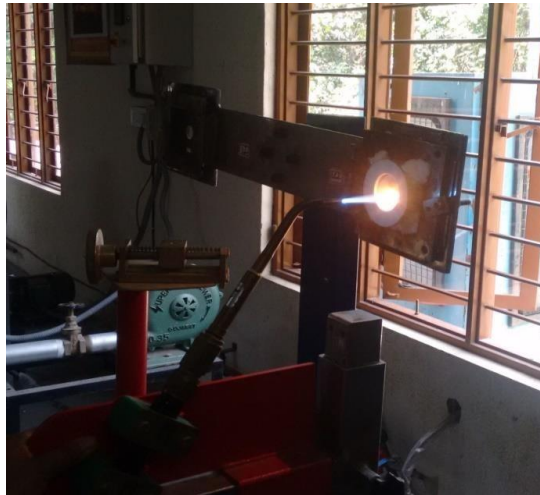
The research piston was subjected to thermal shock cycle which involves expose the research piston crown to 550 $^{\circ}\text{C}$ temperature for 5 minutes followed by cooling for 1 minute in ambient condition and repeated this cycle number of times. In the thermal shock test rig facility, the test sample was moved in and out of the flame so that the ceramic coating on the research piston crown is

subjected to thermal shock. The coated research pistons were subjected to 100 thermal shock cycles and the TBC coating was inspected to check coating degradation if any.

Fig. 8: Thermal Shock Test Set-Up

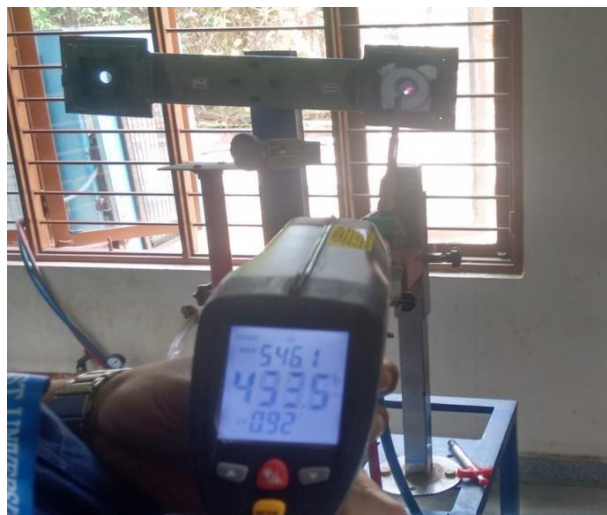
The thermal barrier test involves exposing the TBC coating surface to different temperatures and measure the temperature drop across the ceramic coating to determine the efficiency of the TBC coating. In this test, surface of research piston crown having TBC coating was exposed to different temperatures (from 200 to 550 °C) using an oxy-acetylene flame and recorded the temperature underneath TBC coating after steady state condition achieved. The temperature drop across the coating of research piston at various temperatures was measured using infra-red thermometer to check the thermal efficiency of TBC coating. The test duration was about 2 hours.

Fig. 9: Infra-Red thermometer used for temperature measurement

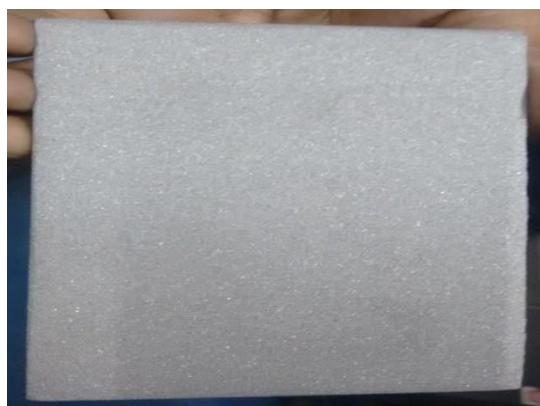
Shows the top coat surface of the multi-layer coated research piston and test coupon. The top coat was observed with rough surface. The surface hardness of the TBC surface was measured with surface roughness meter and the average surface roughness value (R_a) was about $9.2\mu\text{m}$ shows the high magnification SEM Micrograph of the top coat surface. It could be observed that that there was no micro level defects such as cracks, porosity, etc.

Fig. 10: TBC coating on Test Coupon

- There were no defects such as cracks, porosity, etc. observed in the TBC coating. The coating surface was slightly rough and the surface roughness value (Ra) was about 9.2 μm

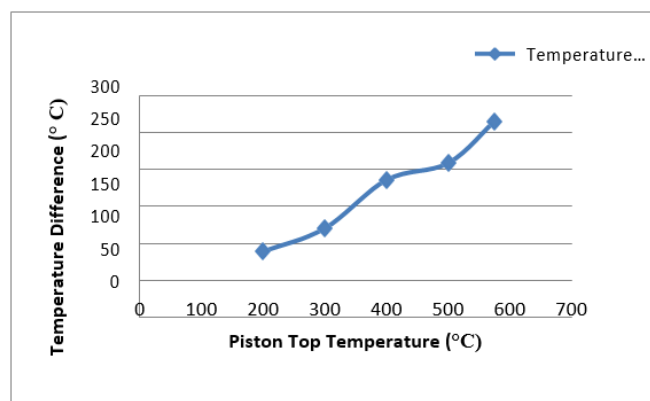
The test results of thermal barrier test. It can be observed from the graph that maximum temperature drop of 265 $^{\circ}\text{C}$ was observed when the temperature of TBC surface was maintain at 590 $^{\circ}\text{C}$. In thermal shock test, after 90 cycle's degradation / delamination of coating was observed and hence the test was stopped after 100 cycles.

Fig. 13: Temperature Difference on Various Piston Top Temperatures

- In thermal barrier test, a maximum temperature drop of 265 $^{\circ}\text{C}$ was observed at 590 $^{\circ}\text{C}$. Delamination of bond coat was observed after 90 cycles.

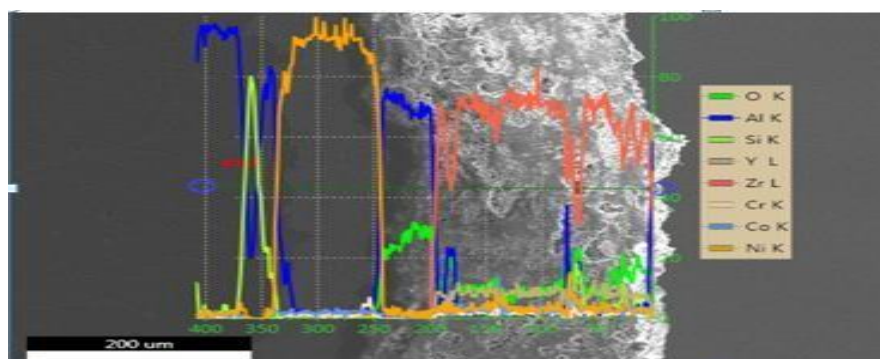
Figure shows the line scan profile across the coating with elements such as Ni, Zr, Y, Al, Si, O, Etc.

Fig. 23: EDS Line Scan Profile across Coating

Different layers (Bond coat + Top coats) and the interfaces were identified clearly using EDS elemental analysis and line scan profile. This helped in making distinction between coating layers and measuring the coating thickness precisely at various locations.

- Different layers (Bond coat + Top coats) and the interfaces were identified clearly using EDS elemental analysis and line scan profile. This helped in making distinction between coating layers and measuring the coating thickness precisely at various locations.
