INTERNATIONAL JOURNAL OF ADVANCE RESEARCH, IDEAS AND INNOVATIONS IN TECHNOLOGY

(Volume 7, Issue 2 - V7I2-1514)

Structural health analysis and monitoring of RC jetty structure and rehabilitation methodology

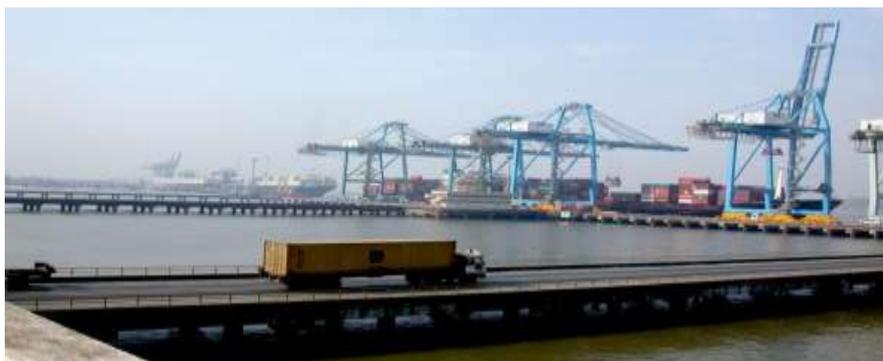
Fig.1.1: Jetty

JETTY : It is a structure on open sea coast which extends into body of the water

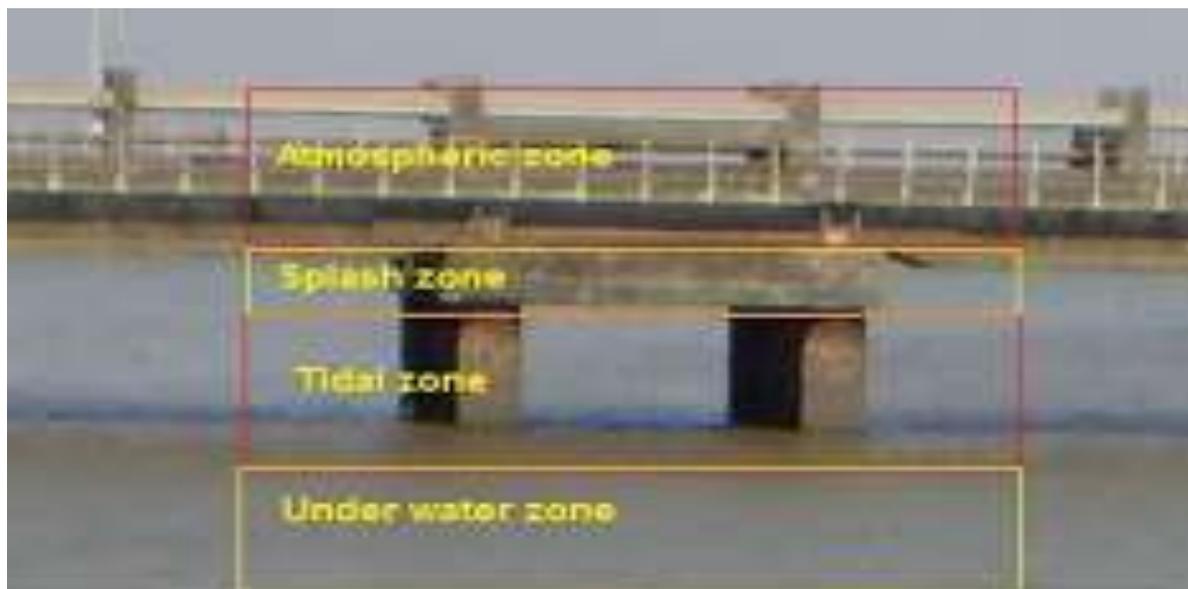
Fig. 1.2: Various Zones of Exposure of Jetty Structure

While studying the jetty structure it is very much necessary to understand that the same structure has various degree of deterioration and the deterioration patterns also changes within the same structure. This happens because various parts of the structure has different exposure conditions. Hence depending upon exposure conditions the jetty structure can be bifurcated in different zones as under.

Under water zone: In this zone structure is directly in contact with sea water which contains lots of corrosive agents & salinity.

Tidal zone: In this zone there is intermittent wetting and drying of the concrete surface which leads to deterioration at very fast rate.

Splash zone: In this zone, the waves coming from sea splashes on the concrete surface which contains corrosive agents.

Atmospheric zone: As surrounding air is saline, this causes the salt fumes getting sprayed on the structure, thus impregnated in concrete surface.
