# INTERNATIONAL JOURNAL OF ADVANCE RESEARCH, IDEAS AND INNOVATIONS IN TECHNOLOGY

(Volume 7, Issue 4 - V7I4-1189)

## Anterior fractured tooth restoration using fiber-reinforced composite: A case report

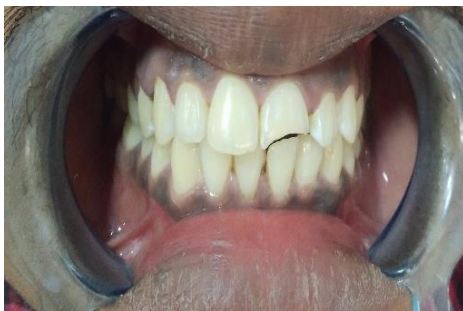
Preoperative clinical photograph with 21

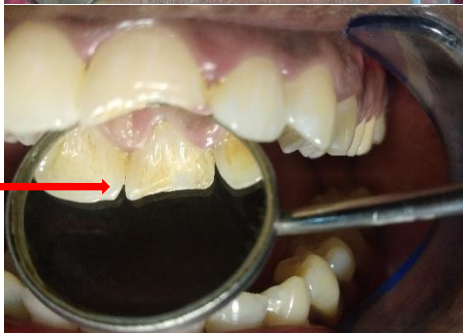
Placement of palatal groove on distal side

Oral prophylaxis was done then preoperative photographs were taken . The area to be restored was dried; then primary and secondary bevels were given on the respective tooth ; followed by placement of 1 groove palatally using No 245 straight fissure carbide bur. The groove was placed only distally as mesially there was enough natural tooth structure present. The groove was placed parallel to long axis of tooth so as to resist the forces .Dimensions of groove were – ( 2×1×0.8 ) mm that is Length× breadth× depth.

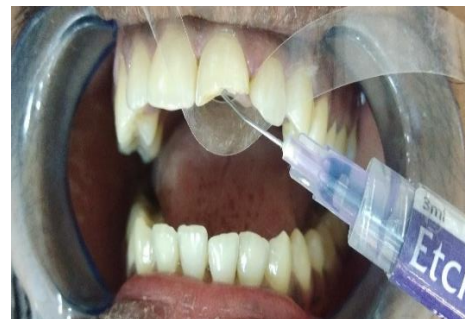
Acid etching with 37% Phosphoric Acid

After air drying the tooth; etchant (37% phosphoric acid) is applied for 15 seconds. Then the etchant is removed using water spray and again dried and isolated . Then bonding agent is applied and then cured for 20 seconds. This was followed by placement of interlig fibres of length 4mm within the palatally placed groove, and light cured. Then the tooth was restored with composite resin restoration. After proper alignment and contouring, finishing and polishing procedure was completed.

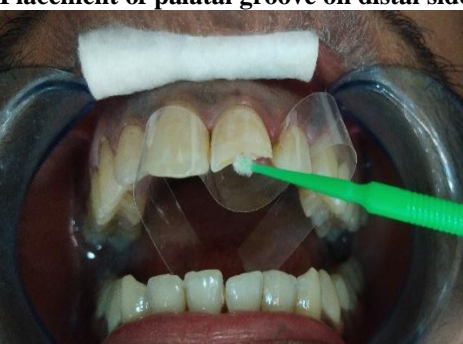
Application of Bonding agent with 21

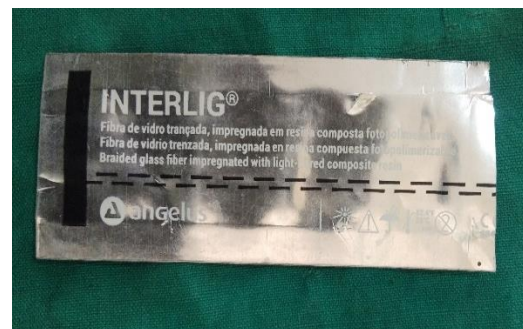
Interlig Composite fibres

Interlig is a structure of intertwined glass fibers impregnated with light-cured composite resin. COMPOSITION - Glass fibers (weight) -  $60 \pm 5\%$ . - Impregnated resin (weight)  $40 \pm 5\%$ : Bis-GMA, diurethane, barium glass, silicon dioxide, catalysts<sup>6</sup>. Fibre reinforced composite can also be used in case of splinting, reinforcement and repair of acrylic resin bridges, fabrication of space retainers in pediatric dentistry<sup>6</sup>.

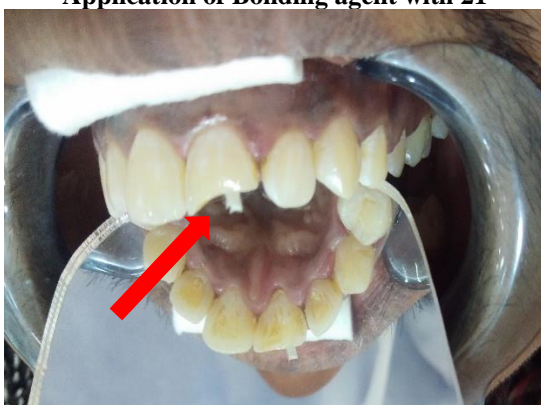
Placement of Fibres (4mm length) in palatal groove of 21

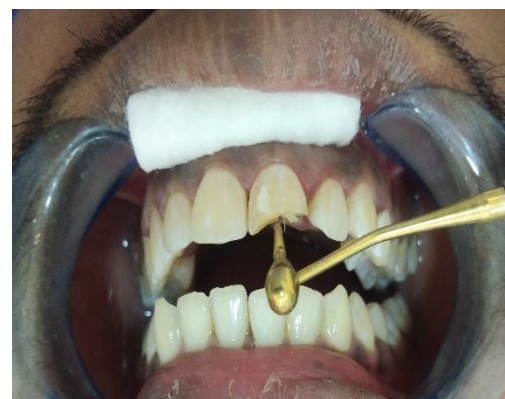
Application of composite resin with 21

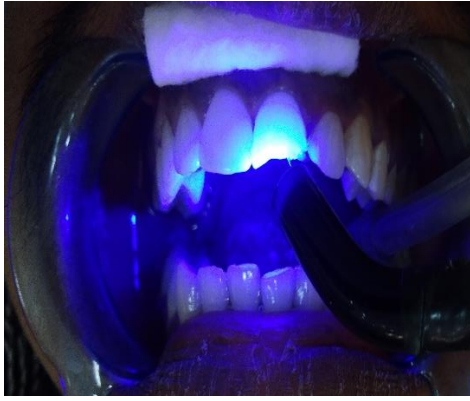
**Light curing procedure with 21**

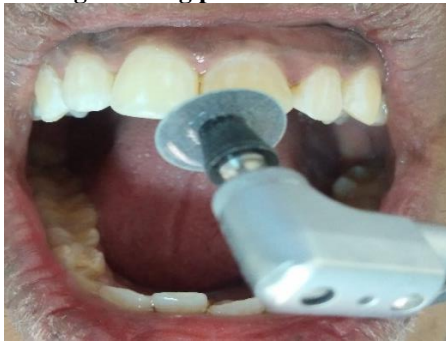
**Final polishing with rubber disk**

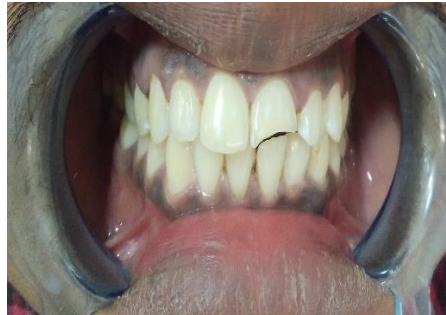
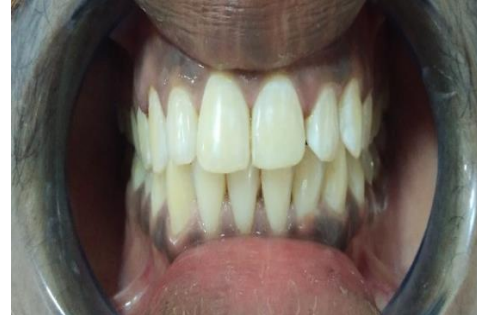
**Preoperative and Postoperative appearance of with 21**
