INTERNATIONAL JOURNAL OF ADVANCE RESEARCH, IDEAS AND INNOVATIONS IN TECHNOLOGY

(Volume 9, Issue 2 - V9I2-1126)

Aesthetic enhancement of discolored non-vital teeth – A conservative approach

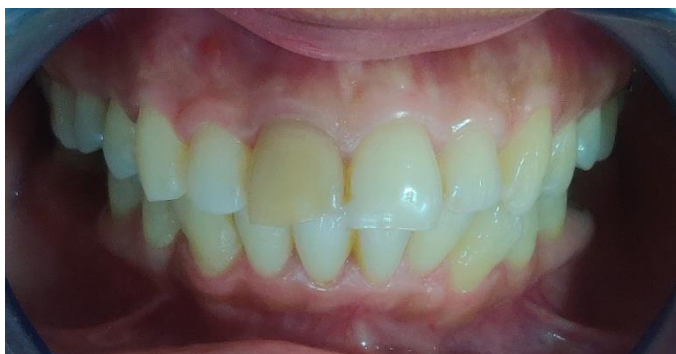
Figure-1 Pre-operative photograph

A 25-year-old female patient reported to the Department of Conservative Dentistry and Endodontics, Government Dental College and Hospital Aurangabad, complaining of pain, pus discharge and discoloration with her maxillary right central incisor, i.e. 11 (Figure 1). The patient gave a history of trauma 4 years ago in the same region.

On clinical examination, Ellis class IV fracture with yellowish-brown discoloration of the crown was observed with 11. A sinus tract opening was also observed in the same region, which was traced with a size 25 guttapercha point using a radio-visiograph. The tooth was also tender on vertical percussion. Intraoral periapical radiograph revealed periapical rarefaction with 11 (Figure 2). The tooth also gave a negative response to the electric pulp sensitivity test as compared to the adjacent and contralateral teeth.

Based on these findings, a provisional diagnosis of acute exacerbation of chronic periapical lesion with 11 was established. After discussing the treatment options with the patient, a conservative approach of root canal treatment followed by non-vital bleaching and composite resin restoration of 11 was opted.

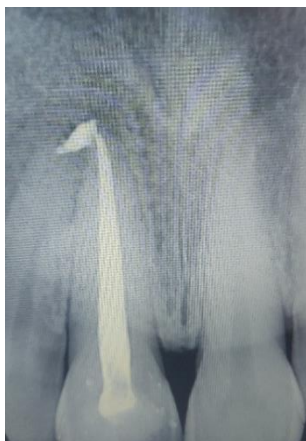
Figure-5 Intracanal medicament placed

Calcium hydroxide was placed as an intracanal medicament (Figure 5) and the patient was recalled every week for follow-up assessment of symptoms. After 3 weeks, healing of the sinus tract was observed, and the patient was asymptomatic (Figure 6). Obturation of 11 with lateral condensation of gutta-percha was done, the access cavity was sealed using Cavit G (3M ESPE) temporary restorative material and the patient was recalled after a week for the bleaching procedure (Figure 7).

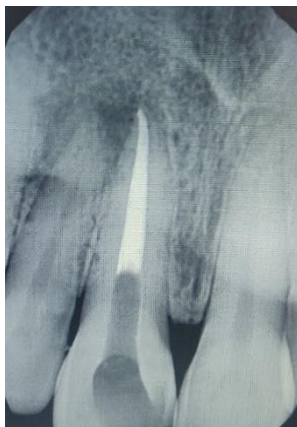
After isolation of the tooth using rubber dam, the temporary restoration was removed, and the endodontic access cavity was modified to ensure that no filling remnants were present in the pulp chamber and pulp horns. The gutta-percha filling was removed from the

access cavity to 2mm apical to the cemento-enamel junction using gates-glidden drills (Figure 8). A 2 mm plug of glass ionomer restorative cement was then placed over the gutta-percha in the cervical region to prevent percolation of bleaching agent to the surrounding periodontal tissues (Figure 9a and 9b).

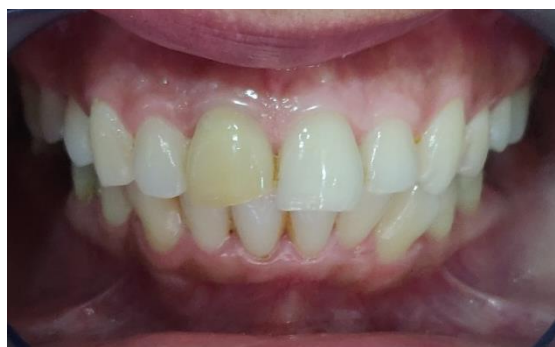
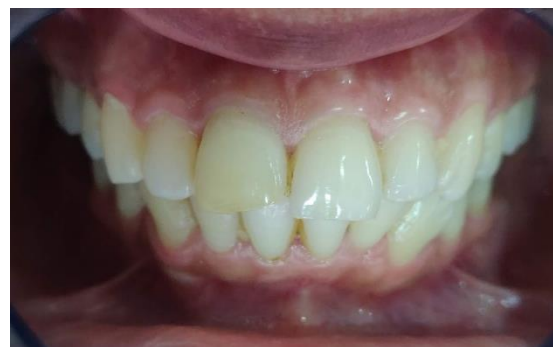
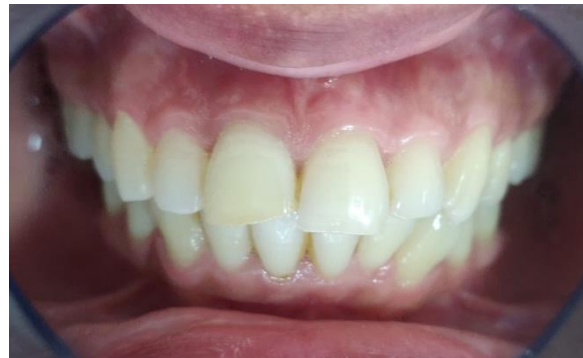
The patient was recalled after every 7 days for assessment of the bleaching results. Weekly replacement of the bleaching agent with a fresh paste of sodium perborate was also done by repeating the same procedure. After 3 weeks, the anticipated bleaching results were achieved with an improved cosmetic appearance (Figure 12a, 12b and 12c).

Figure-12a Bleaching result after 1 week

Figure-12b Bleaching result after 2 weeks

Figure-12c Bleaching result after 3 weeks

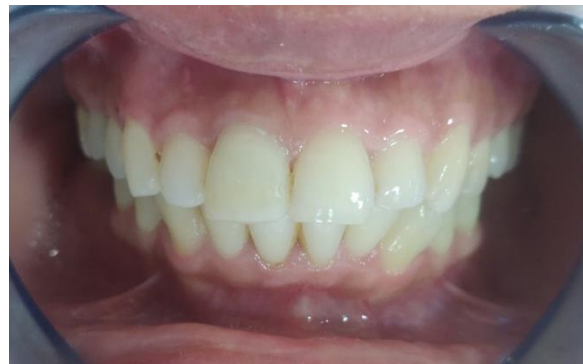
Figure-13 Post-operative photograph

After the completion of bleaching treatment, the pulp chamber was cleaned, dried. The cavity was closed with Cavit G (3M ESPE) temporary restorative material and the patient was called after 2 weeks for permanent restoration and build-up of the fractured tooth structure with composite resin (Figure 13).

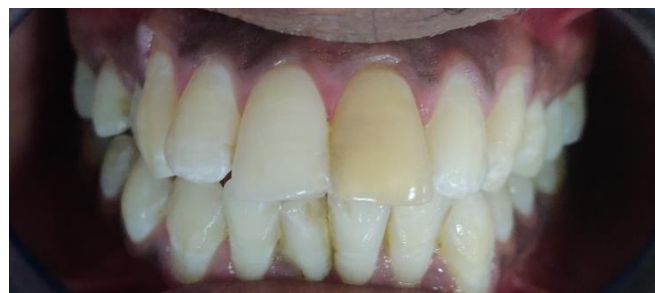
Figure-14 Pre-operative photograph

A 23 year old male patient was referred to the Department of Conservative Dentistry and Endodontics, Government Dental College and Hospital Aurangabad, because of pain and discolouration with his maxillary left central incisor, i.e. 21 (Figure 14). He gave a history of trauma in the same region 6 years ago. The patient also reported that he had undergone root canal treatment with the same tooth 3 months ago.

Clinical examination revealed dark yellowish discoloration and tenderness on vertical percussion with 21. Intraoral periapical radiograph revealed incomplete obturation of the root canal of 21, with the obturating material extending only till the middle one-third of the canal. Calcification of remaining unobturated canal was also noted. Periapical rarefaction of the same tooth was observed in the radiograph.

Based on these findings, a provisional diagnosis of calcific metamorphosis and failed endodontic treatment with 21 was established. After discussing the treatment options with the patient, repetition of the root canal treatment followed by non-vital bleaching of the concerned tooth was decided.

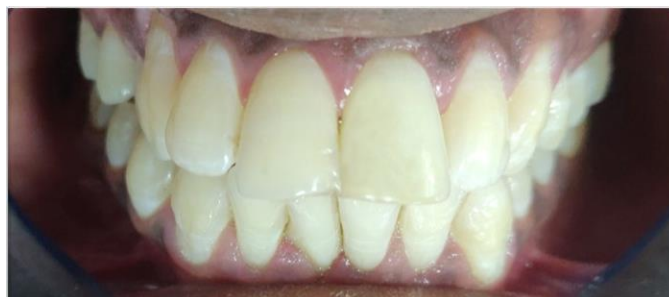
Figure-15 Post-operative photograph

The same procedure was repeated for 21 under rubber dam isolation, using a paste of sodium perborate by mixing with distilled water for achieving the bleaching results. The patient was recalled at weekly intervals for three weeks, during which the sodium perborate mixture was refreshed. After 3 weeks, satisfactory aesthetic result was achieved (Figure 15), following which the pulp chamber was cleaned, dried and the cavity was closed with Cavit G (3M ESPE) temporary restorative material. The patient was recalled after 2 weeks for the final permanent restoration with composite resin.
