INTERNATIONAL JOURNAL OF ADVANCE RESEARCH, IDEAS AND INNOVATIONS IN TECHNOLOGY

Indexing Hydrological Parameters of Narmada River influenced by Socio Biological Activities

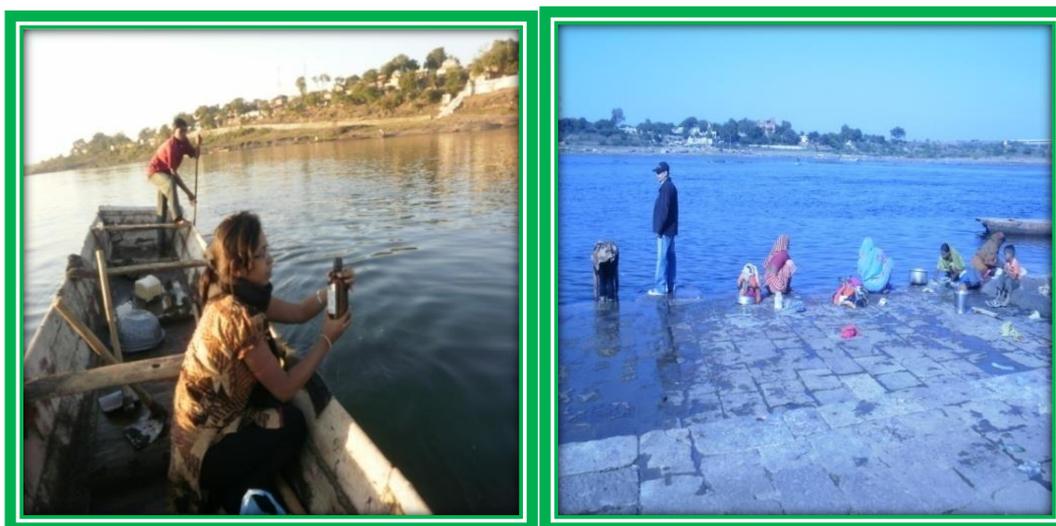
FIG 02: sampling from center

FIG 03: sampling from Catchment area

The water samples were collected every month from September 2010 to September 2012 from sampling station Moretakka. The collection of water samples has been done from selected station in horizontal manner i.e. from both sides of the catchment areas and just from the center of the River every month during the study period. Water samples were collected in air tight autoclaved sterile black bottles.
